AFFDL-TR-77-128

YC-14 INTERIOR NOISE MEASUREMENTS PROGRAM

BOEING COMMERCIAL AIRPLANE COMPANY
P. O. BOX 3707
SEATTLE, WASHINGTON 98124

TECHNICAL REPORT AFFDL-TR-77-128
Final Report October 1975 - October 1977

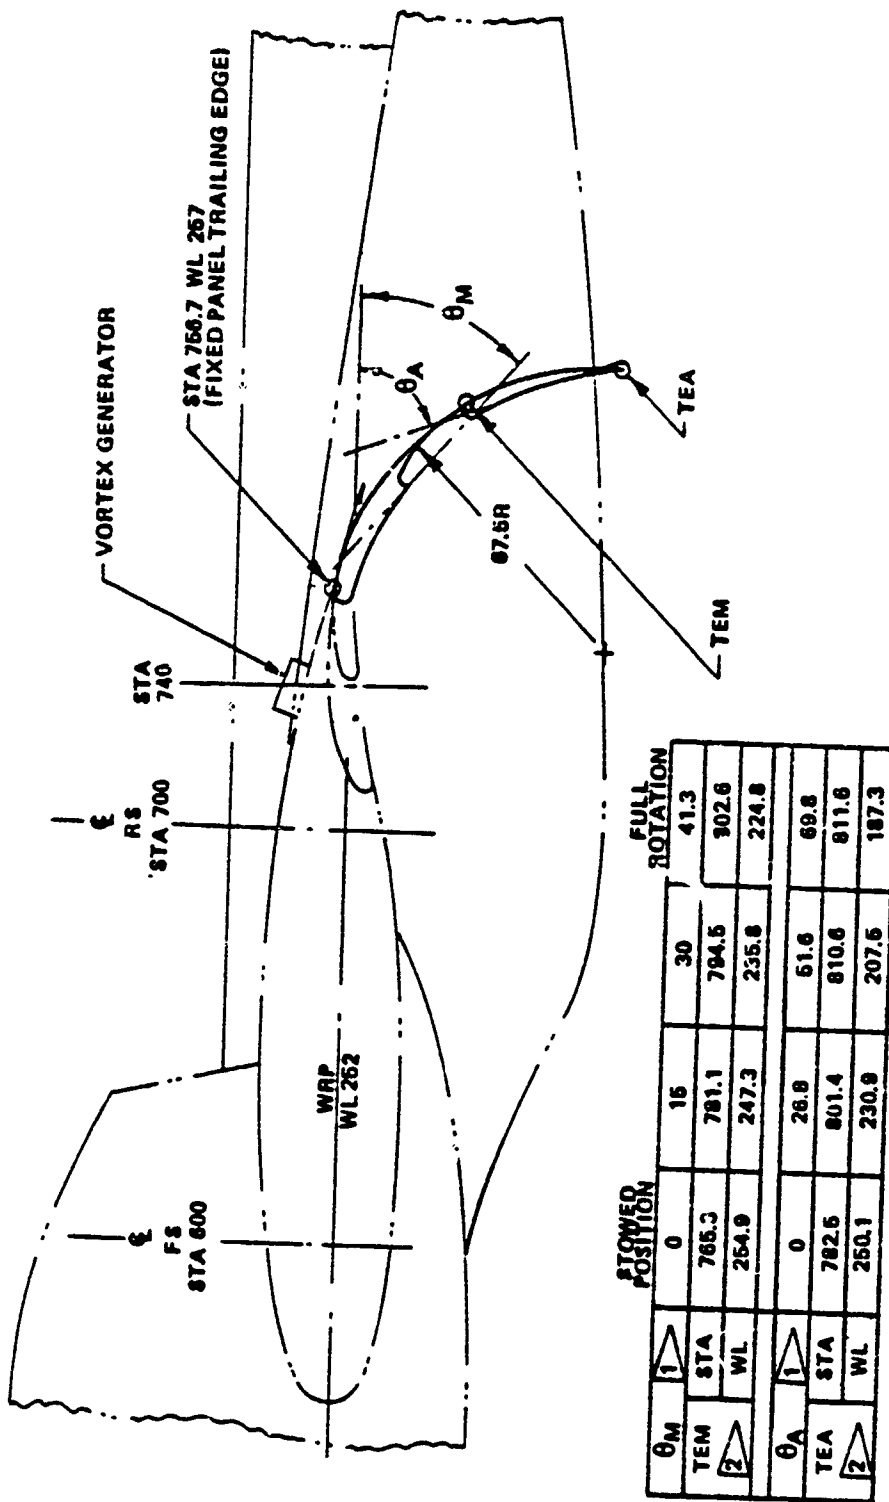
Figure 6 YC-14 Flight Control Surfaces

- 1 THE BROKEN LINES THRU MAIN FLAP (AFT FLAP) DEFINING θ_M (θ_A) COINCIDE WITH THE WRP IN THE STOWED POSITION. HENCE θ_M (θ_A) DEFINES ANGLE OF ROTATION FROM ITS STOWED POSITION.
- 2 TEM INDICATES THE LOCATION OF THE TRAILING EDGE/MAIN FLAP AND TEA INDICATES THE APPROXIMATE LOCATION OF THE TRAILING EDGE/AFT FLAP.

USB FLAP GEOMETRY

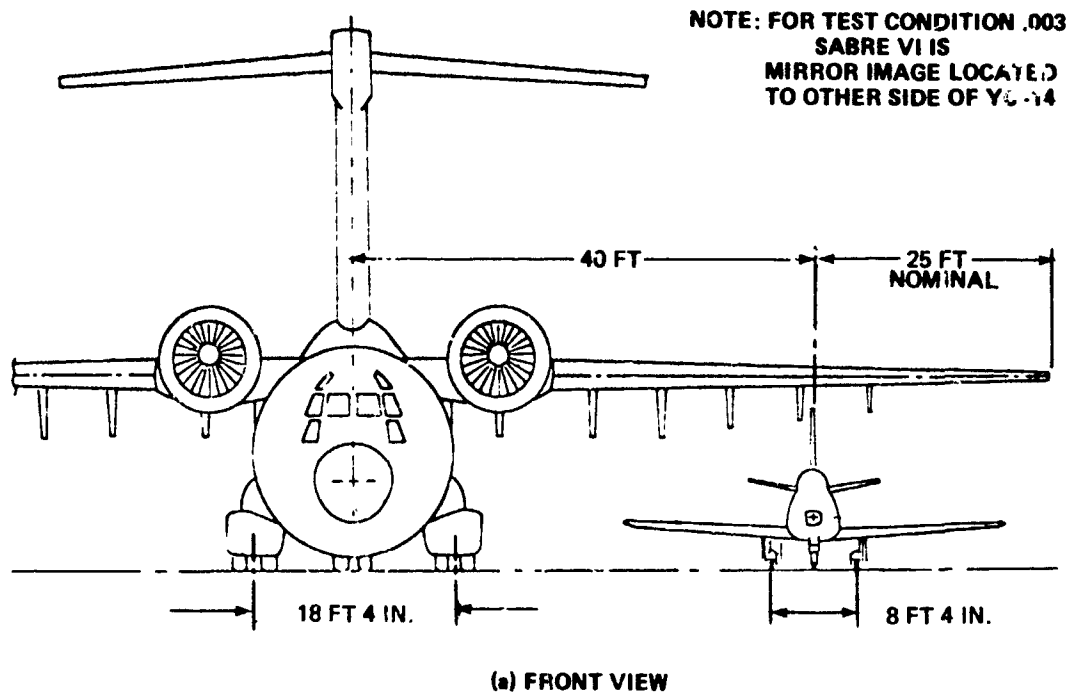
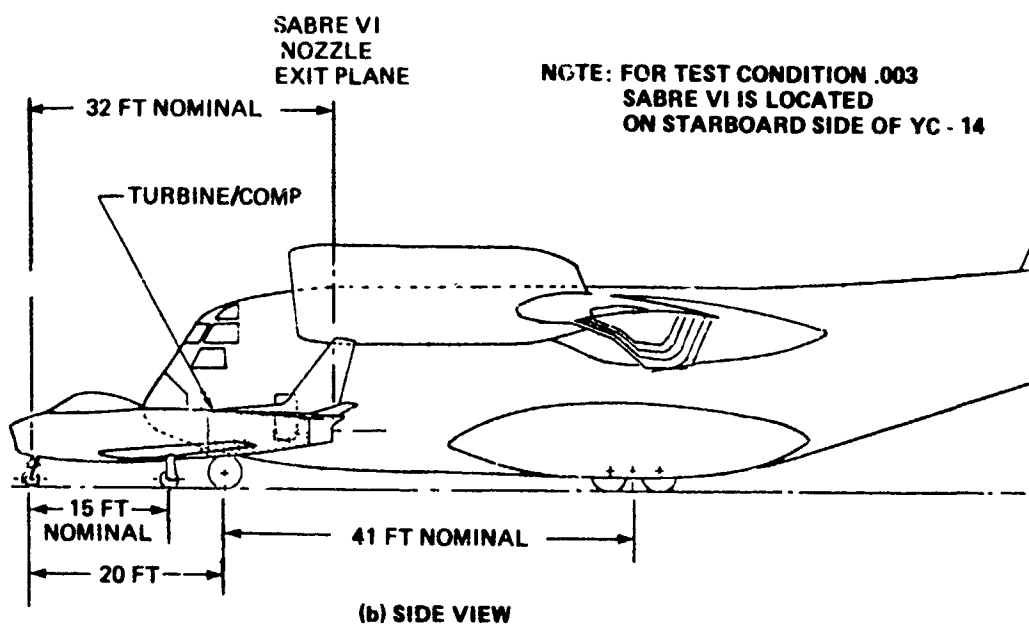
Figure 22 YC-14/Sabre VI Configuration for Test Condition .002

which essentially all flush mounted fuselage microphones and fuselage accelerometers were installed), and to the starboard side during condition .003. Figure 22 provides dimensional data on the position of the Sabre VI relative to the YC-14. During both conditions, .002 and .003, at least 1 min of stabilized (Sabre VI operation at $N_1 = 7220$ RPM) microphone and accelerometer data was obtained. Weather conditions were clear and windless.

For conditions .002 and .003 (Sabre VI to port and to starboard) only YC-14 systems per condition .001 were on within the airplane. Again, the YC-14 engines were off. Significant external noise was generated by the engine of the Sabre VI, a pure turbojet, which was run at $N_1 = 7220$ RPM (90% of takeoff N_1) with the Sabre VI parked in close proximity to the YC-14. During condition .002, the Sabre VI was to the port side of the YC-14 (the side on

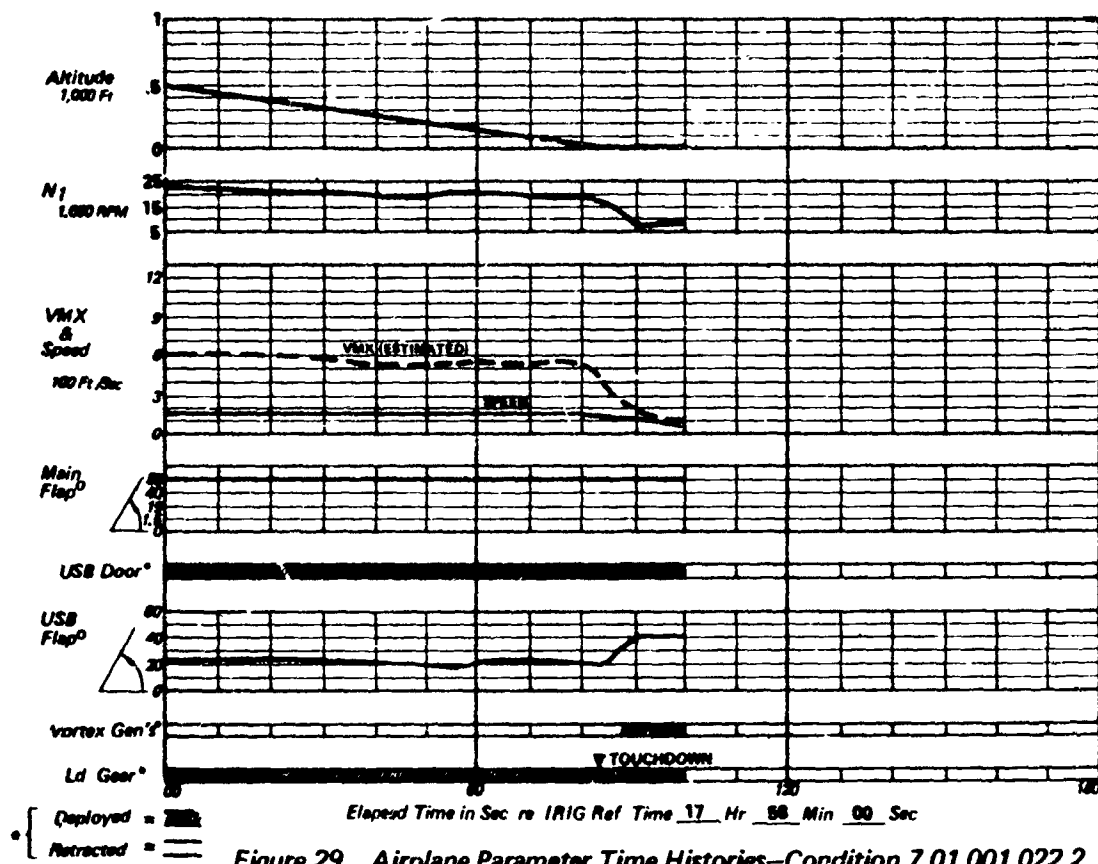
Figure 29 Airplane Parameter Time Histories—Condition 7.01.001.022.2 (Landing, Flaps 60)

Conditions .022, .022.1 and .022.2 were continuous landings at FLAPS 45, FLAPS 30, and FLAPS 60 settings, respectively. For condition .022 the USB flaps were at 20° , for condition .022.1 at 0° , and for condition .022.2 the USB flaps modulated about 20° . All landings were on 3° glide slopes or less at speeds well above (20 to 50 ft/sec above) anticipated STOL speed. Hence, none of these landings represents a strict STOL landing. Data were acquired from at least 500 ft altitude to touchdown and on through a portion, if not all, of the runway deceleration. Airplane behavior for these conditions is shown in Figures 27, 28, and 29.

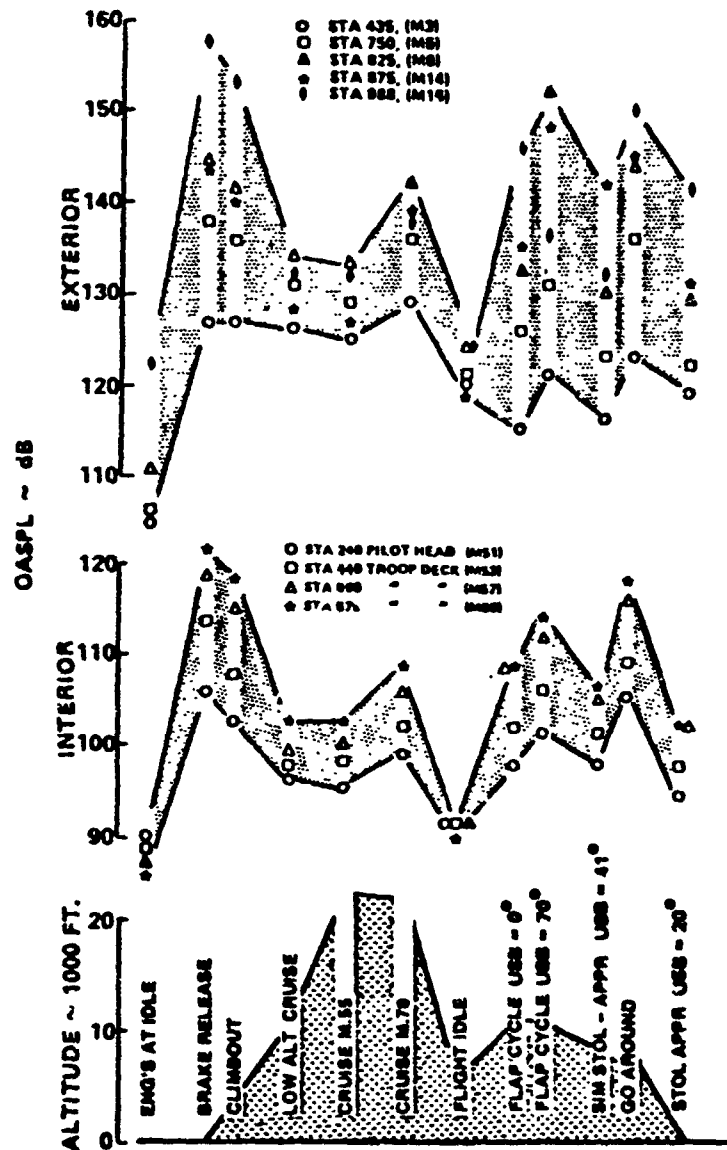
Figure 32 Summary of Exterior and Interior Noise Levels (Same as Figure 3)

- o Similarity in the condition-to-condition variation of exterior and interior overall noise level patterns, suggesting that interior noise is predominantly controlled by exterior fuselage surface noise.

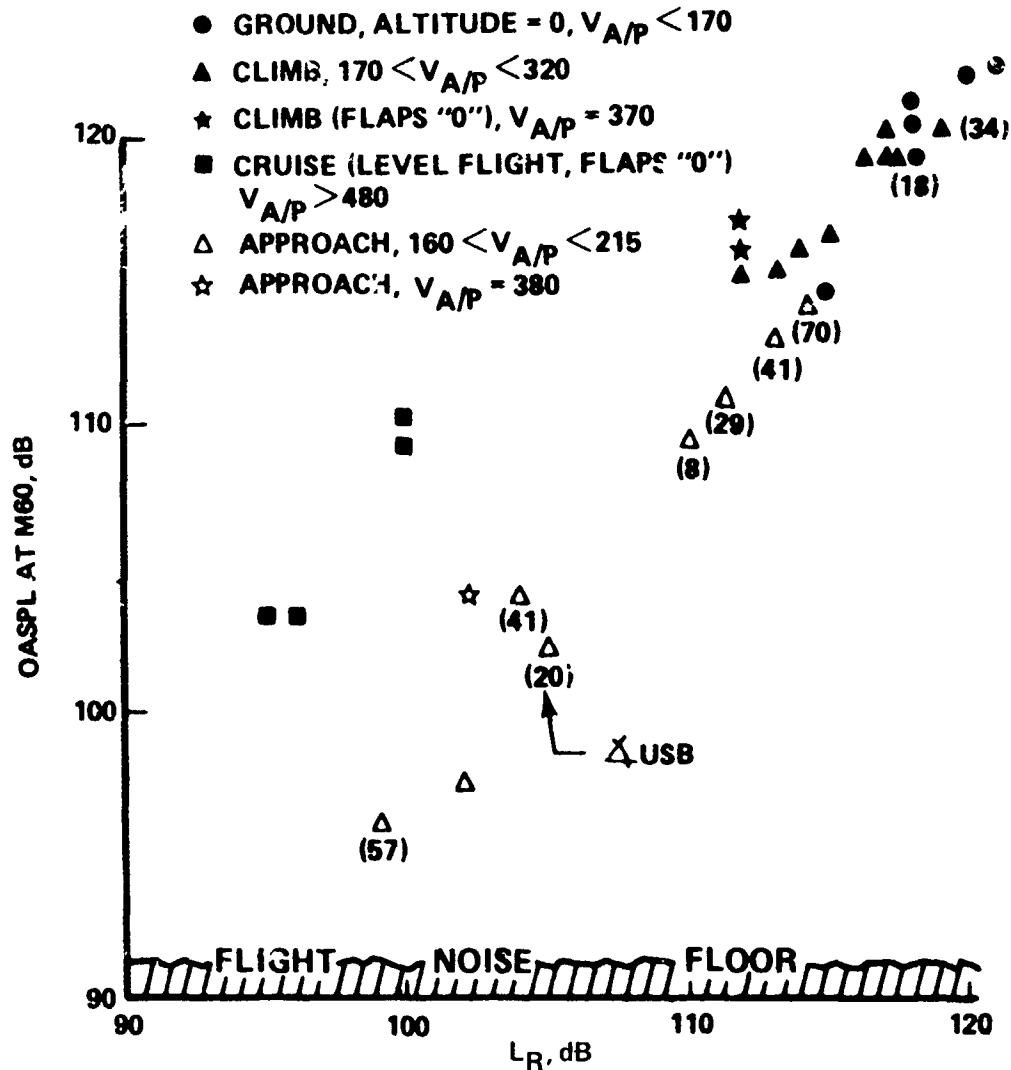
Figure 35 Correlation of Aft Troop Compartment (M60) Overall Noise with L_R Noise Measure

Of the three noise measurements, L_R appears to be the most successful. Hence, Figure 36 shows the overall noise at M60 plotted against L_R for most of the ground and flight conditions performed during the test program. This figure and Figure 35 indicate cruise noise levels higher than would be anticipated based on relative jet velocity.

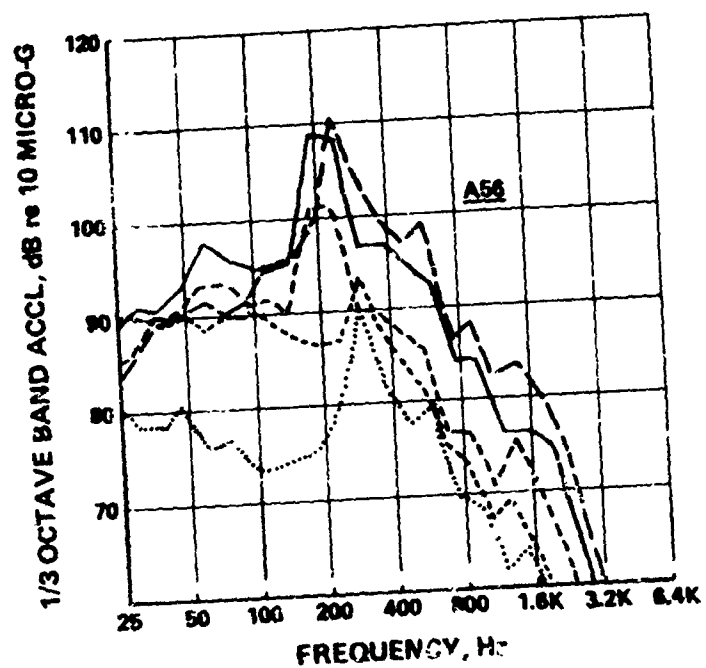
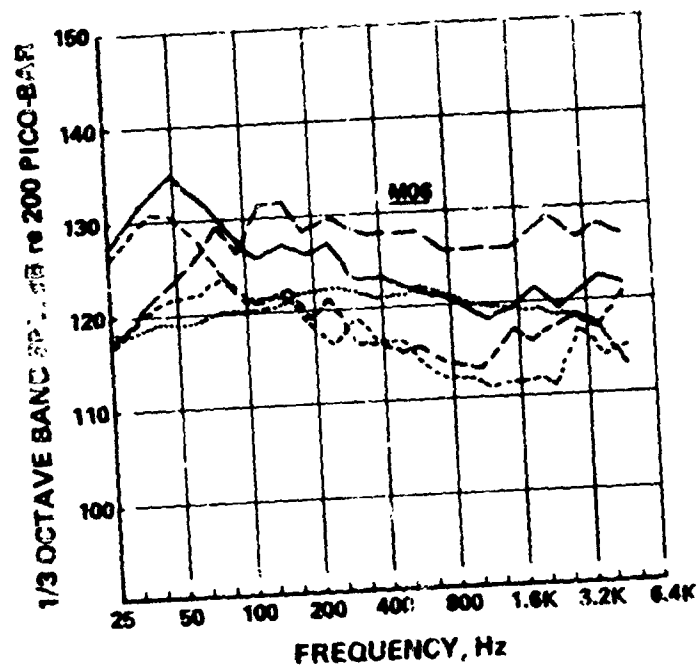
Figure 51 Skin Vibration/Exterior Sound at A56/M06

CONDITION	TYPE	L_{H}
— 7080	GROUND	118
- - - 7130	C.LIMB	116
- - - 7100	GROUND	116
- - - 7140	FLAP CYCLE	110
..... 7140	LOW-ALTITUDE CRUISE	95

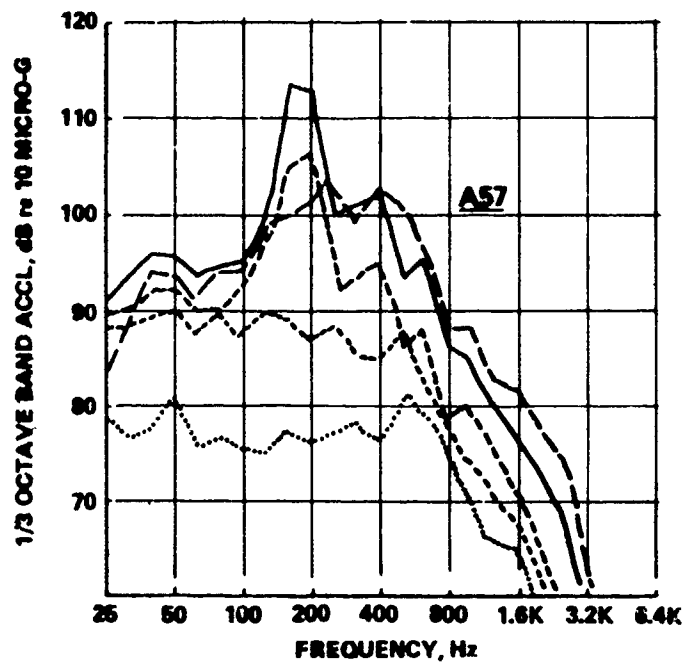
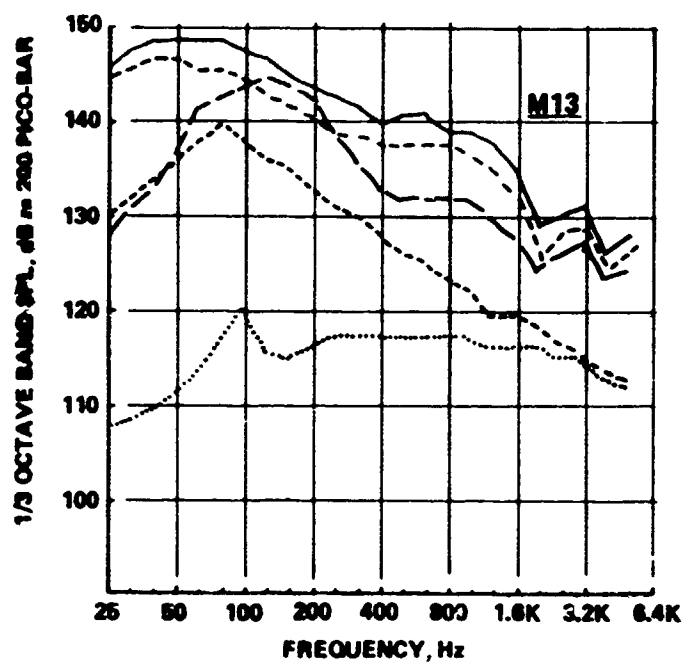
Figure 52 Skin Vibration/Exterior Sound at A57/M13

CONDITION	TYPE	L _R
— 7090	GROUND	118
- - - 7130	CLIMB	116
- - - - 7100	GROUND	115
- - - - - 7190	FLAP CYCLE	110
..... 7140	LOW-ALTITUDE CRUISE	95

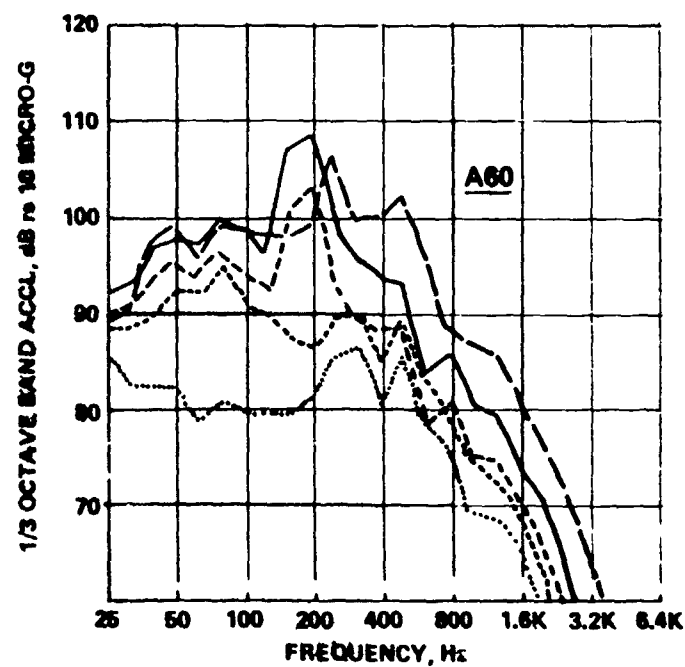
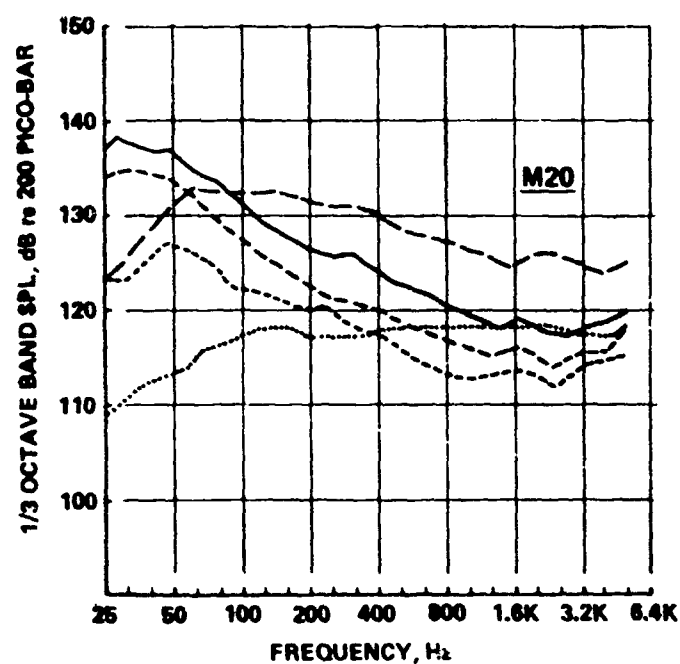
Figure 53 Skin Vibration/Exterior Sound at A60/M20

CONDITION	TYPE	L_R
— 7090	GROUND	118
- - - 7130	CLIMB	116
- · - · 7100	GROUND	115
· · · · 7190	FLAP CYCLE	110
· · · · · 7140	LOW-ALTITUDE CRUISE	95

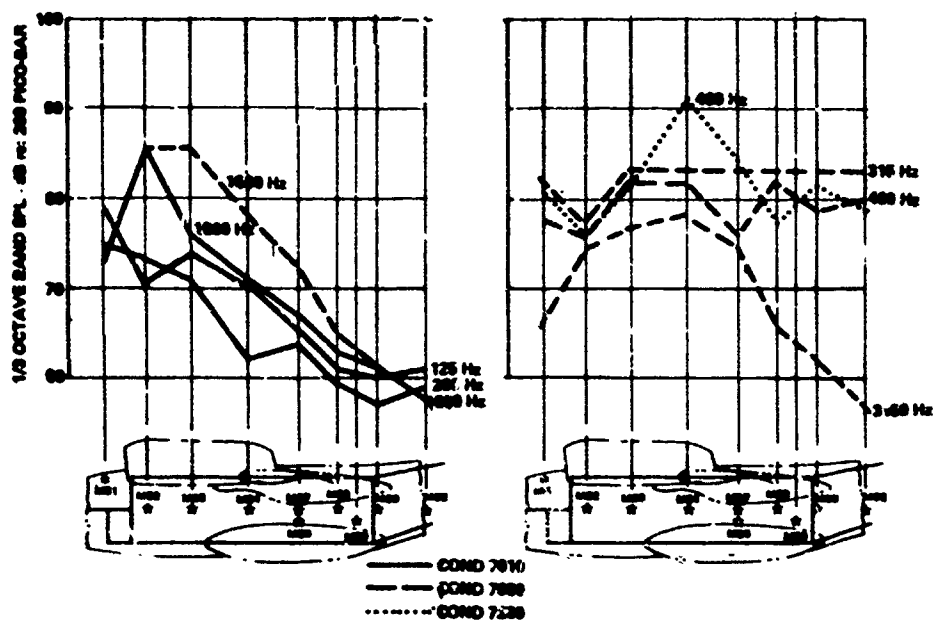
Figure A-12 Distribution of Dominant One-Third Octave Band (Ambient) Noise Levels Along Cabin Center Aisle

Omitting the ambient noise conditions for the moment, spectra for a given condition have similar shapes from front to rear of the airplane. M55 near the sidewall, and nearby center aisle microphone M60, show distinctively higher levels in the 30 Hz through 50 Hz bands than microphones forward of the wing. This effect is currently not fully understood, although some sort of room mode effect is suspected.

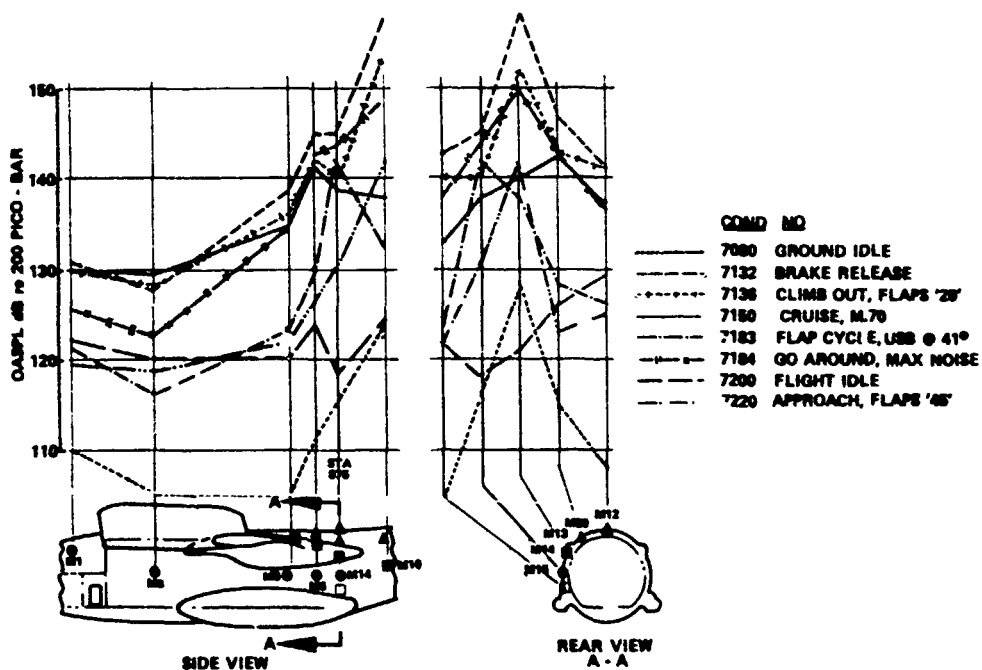
Figure A-14 Summary of External Fuselage Noise Activity

A negligible fore-to-aft noise level gradient is observed only in the case of flight idle (condition 7200). One reason could be that only in the case of flight idle is engine exhaust noise perhaps negligible compared to turbulent boundary layer (TBL) fluctuations over most of the fuselage. It could be that, even in the case of high speed operation such as Mach 0.70 cruise (condition 7150), engine exhaust noise is for a significant portion of the fuselage as important as or more so than TBL fluctuations.

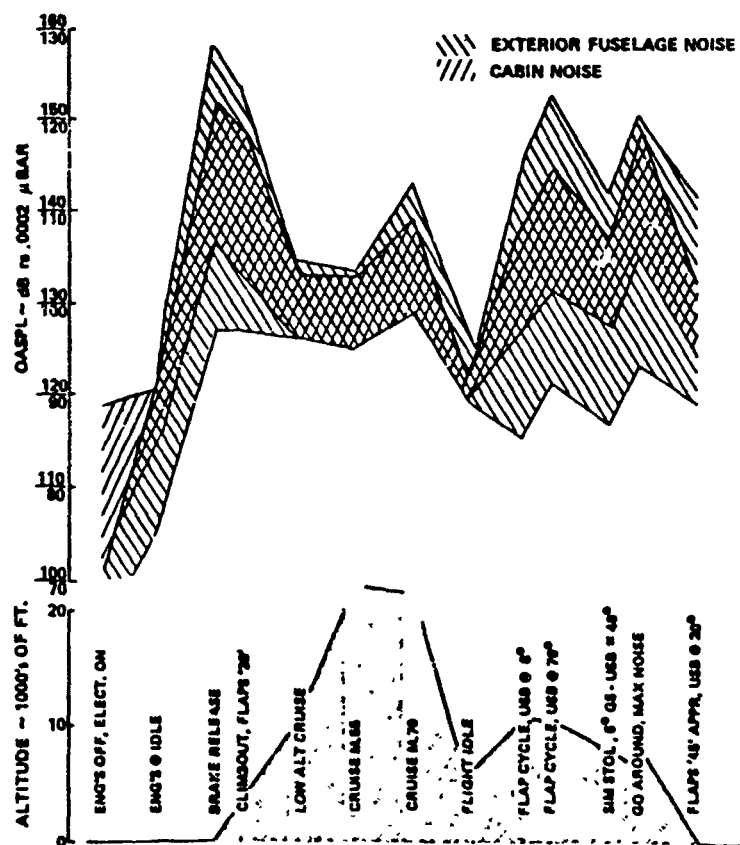
Figure A-23 Summary of Cabin Noise OASPL vs Exterior Fuselage Noise OASPL

While the contents of Figure A-23 are encouraging in their regularity, there remains far more work to bring understanding of interior versus exterior noise even to the level of understanding of exterior noise and of interior noise demonstrated in Sections A.1 and A.2. The work in these two sections on the separate problems of interior noise and exterior noise represents necessary ground work to attacking effectively the coupled problems.

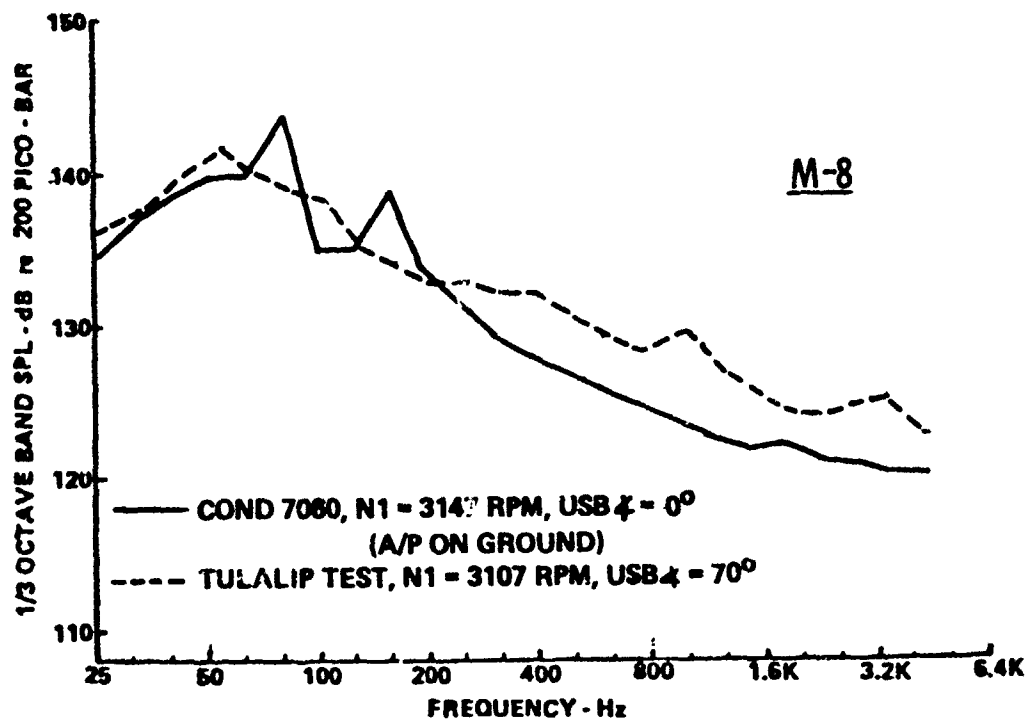
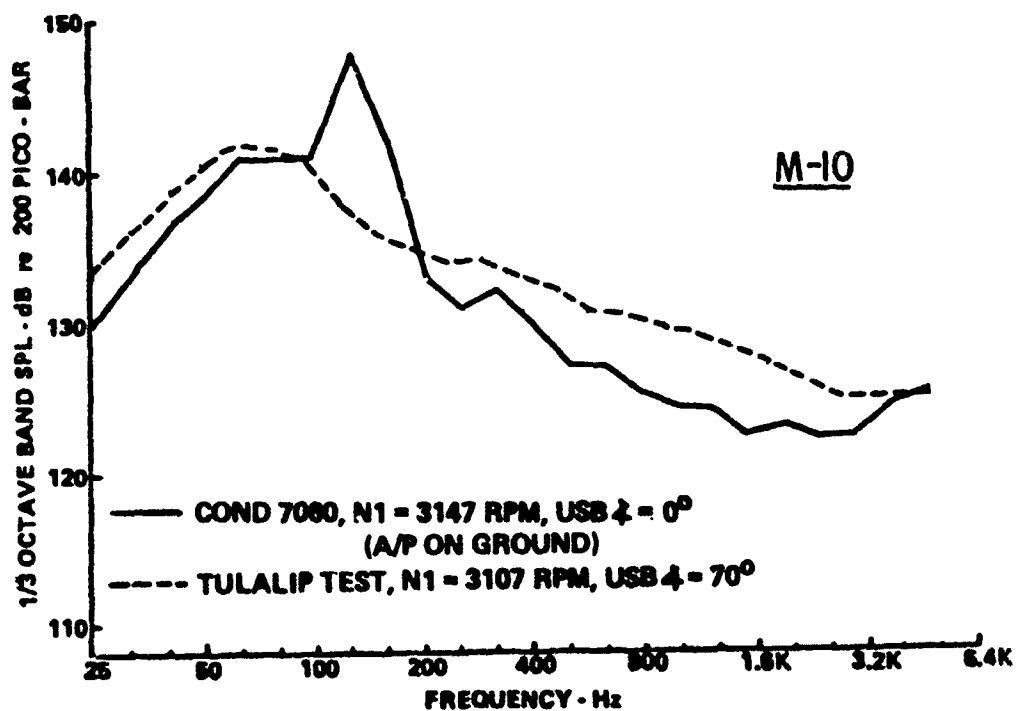
Figure A-77 Comparison of Microphone M8 and M10 Behavior—Current Test Program vs Tulalip Test Program

This general bump behavior is, in fact, observed in essentially all engine-on operations considered in this program. Beyond this, it is observed when an independent source of exterior noise is utilized; e.g., the Sabre VI, and is illustrated in Figure A-79. A candidate partial explanation of this behavior could be low-frequency room modes.
